DEPARTMENT OF TRANSPORTATION

Quality Assurance and Source Inspection

Tower Trial Assembly

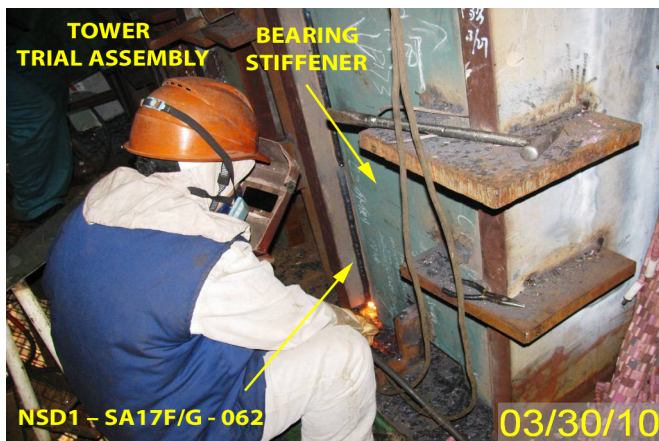
Weld joint # 062 located on North Tower Lift-1 Bearing stiffener Plate NSD1 – SA17F/G. Welder is identified as 037907. ZPMC Quality Control (QC) Inspector is identified as You Qi Guo. The welding variables recorded by QC appeared to comply with the WPS – B – T – 2333 – Tc – P4 – F.
(See attached photo)
